Manhole Inspection Summary

Manhole # S51E__003MH

Location Address: **1 s linwood ave**

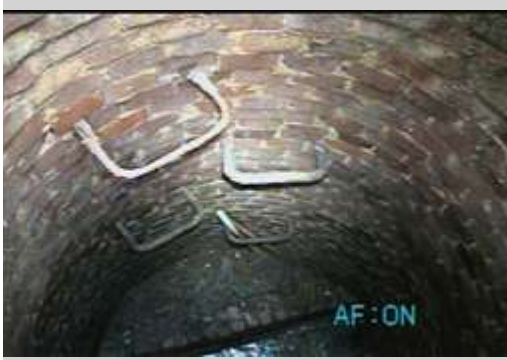
Defect 2

Count: **5** Missing: **1** ☒ **Corroded**

steps

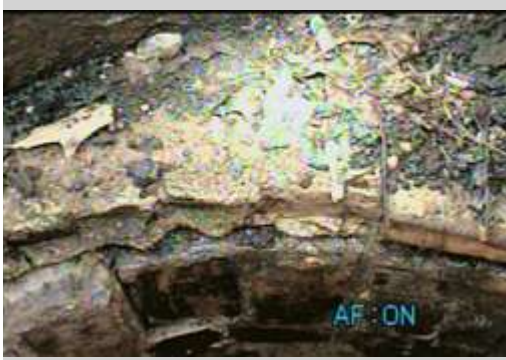
Defect 1

Offset: **1** (in.)

offset

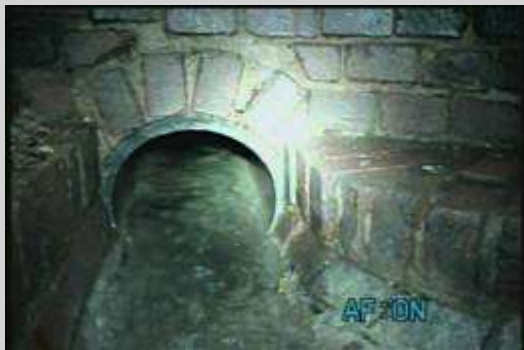
12 O'Clock Outflow

10 in. Circular Gravity Sewer
Pipe Out @ 12 O'Clock

Invert Depth: **10.09** (ft.) Flow Characteristics: **Fast**

Infiltration: **None** Pipe Seal Cond: **Unknown**

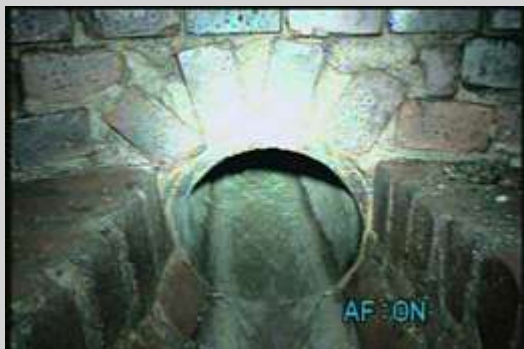
3 O'Clock Inflow

8 in. Circular Gravity Sewer
Pipe In @ 3 O'Clock

Invert Depth: **10.06** (ft.) Flow Characteristics: **Fast**

Infiltration: **None** Pipe Seal Cond: **Unknown**

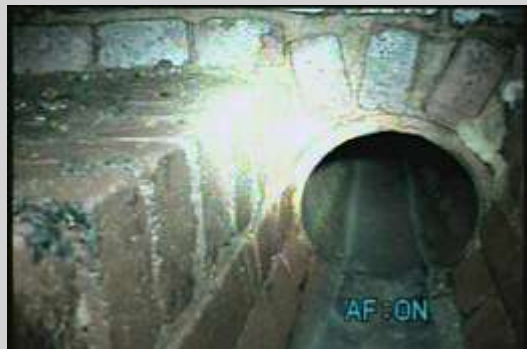
6 O'Clock Inflow

8 in. Circular Gravity Sewer
Pipe In @ 6 O'Clock

Invert Depth: **10.06** (ft.) Flow Characteristics: **Fast**

Infiltration: **None** Pipe Seal Cond: **Unknown**
